# NATURAL AND HUMAN-INDUCED SUBSIDENCE DUE TO GYPSUM DISSOLUTION: A CASE STUDY FROM INANDIK, CENTRAL ANATOLIA, TURKEY

Ergin Gökkaya<sup>1,C</sup> and Esra Tunçel<sup>2</sup>

## Abstract

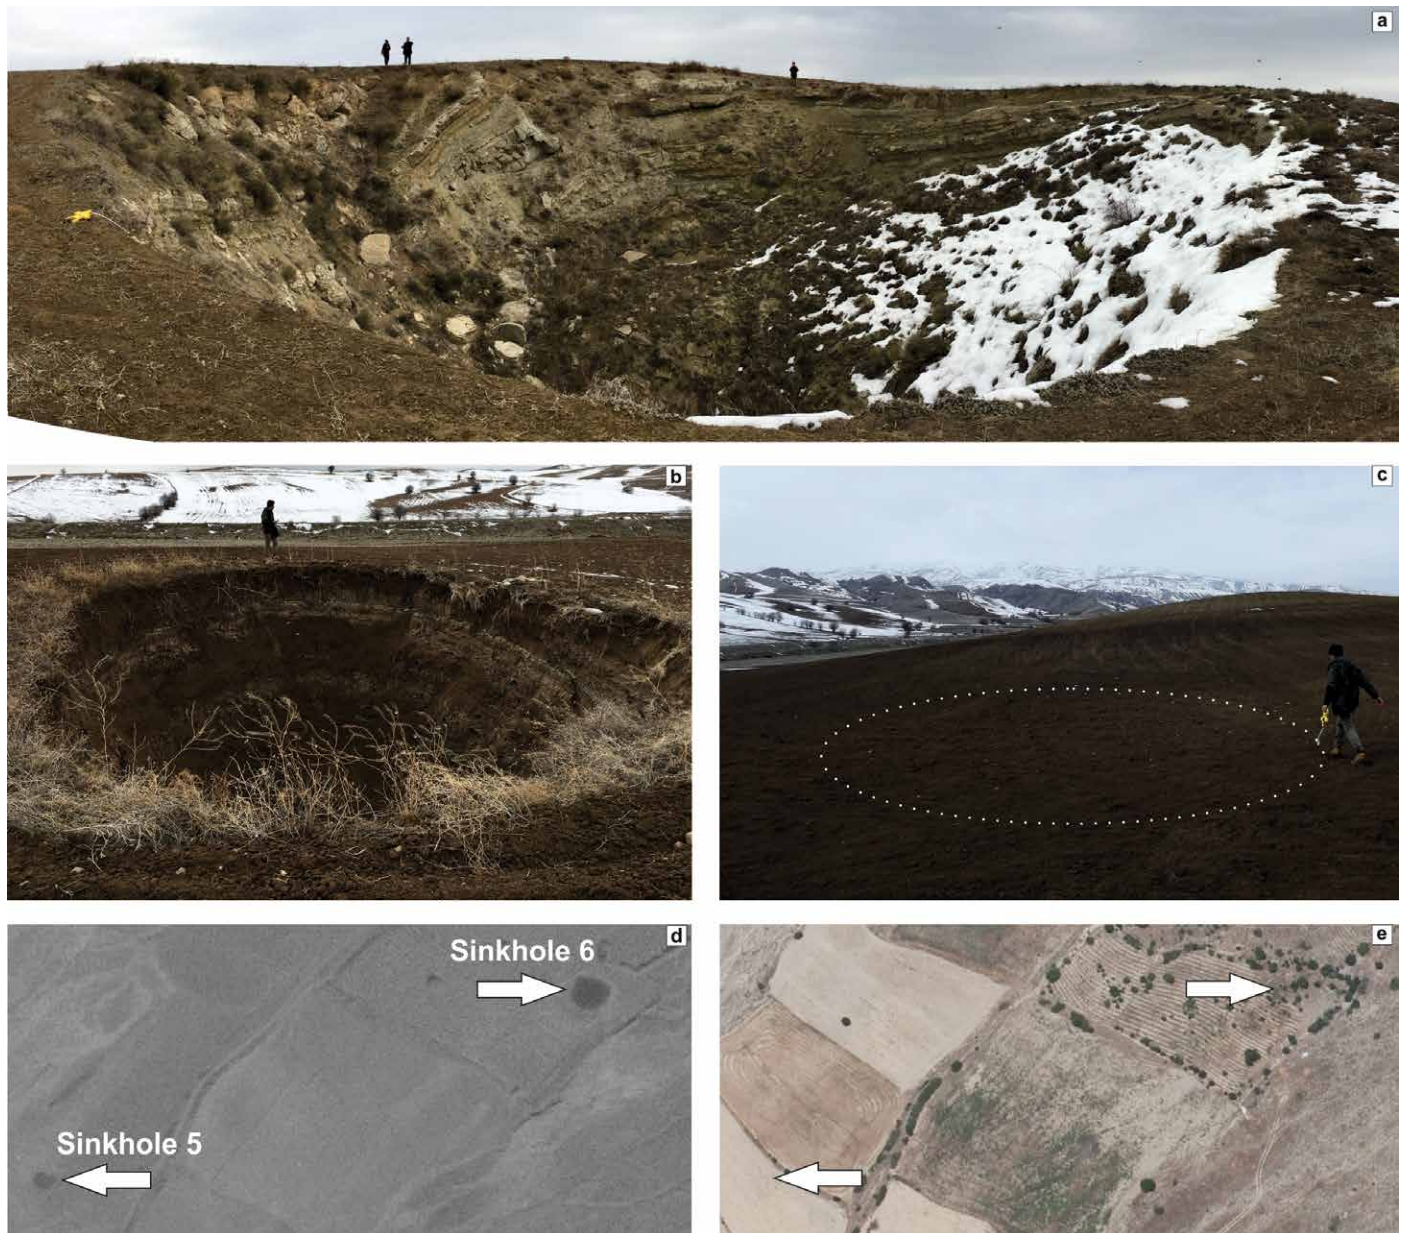
Sinkhole 2 (Fig. 2a) is the largest with a diameter of 44 m and depth of 22.5 m at an altitude of 877 m a.s.l. It is the only bedrock collapse sinkhole and was formed before 1953. Blocks were observed in its bottom and many fractures are visible around the sinkhole, indicating that it has enlarged due to mass wasting. This sinkhole in particular shows that large cavities exist under the terrace.

The most recent sinkhole is number 8 (Fig. 2b), formed in 2012. It is 13 m in diameter and somewhat enlarged since traces of erosion are visible at its margins, and is 10 m deep. The depth of the sinkhole is 5 m greater than the thickness of the alluvial deposit. It is classified as a cover-collapse sinkhole.

The other sinkholes can only be observed in some of the aerial photographs. They have now disappeared because farmers have filled them, canceling the surface features (Fig. 2c, d, e). These buried sinkholes can also be defined as

Figure 2. (a) Panoramic view of Sinkhole 2, the deepest and largest sinkhole in study area. Note separated blocks on the sides. (b) Sinkhole 8, most recent sinkhole in study area. (c) Sinkhole 4, buried by farmers. Soil containing small white pebbles brought from elsewhere mark the sinkhole within the boundary indicated. (d) Historical aerial photograph of sinkholes 5 and 6. (e) Recent view of buried sinkholes 5 and 6.

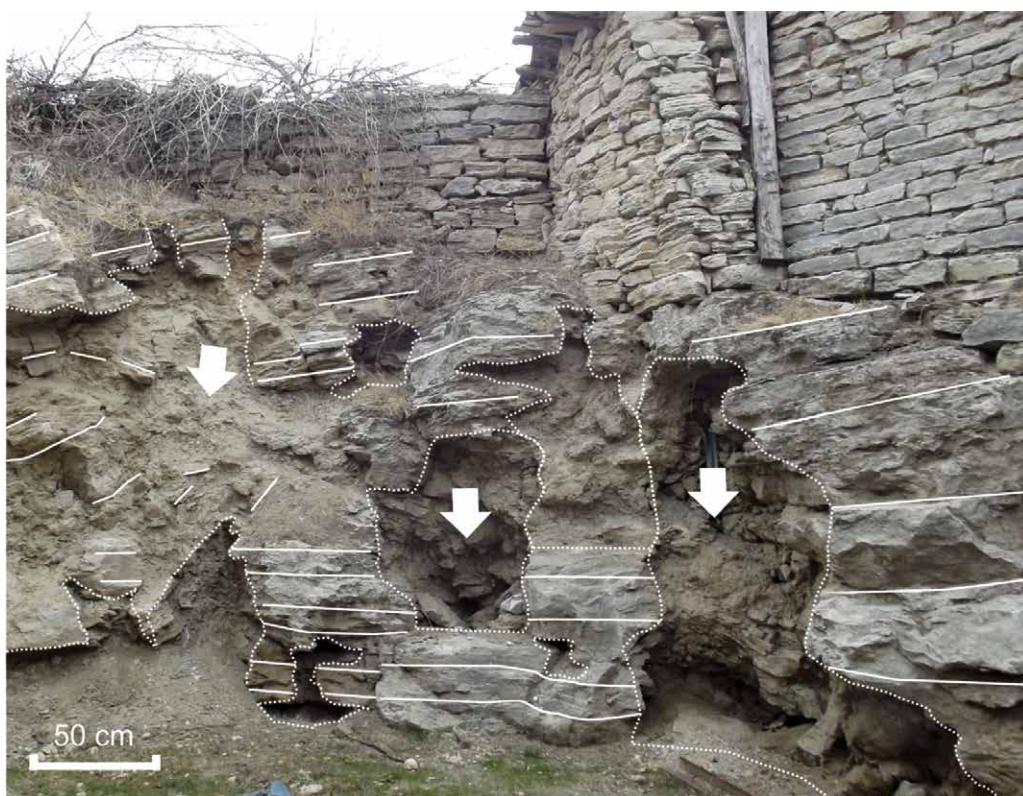
Figure 3. Paleo-subsidence structures in gypsum bedrock. Cavities are filled with karstic residue and gypsum blocks. (Photograph taken on eastern slope of village).

From the borehole logs, registers, and GPR profiles 1 and 5, similar cavities to those in outcrops (Fig. 3) were deduced. They are very superficial, which explains the damage to single-story homes with smaller loads on their foundations.

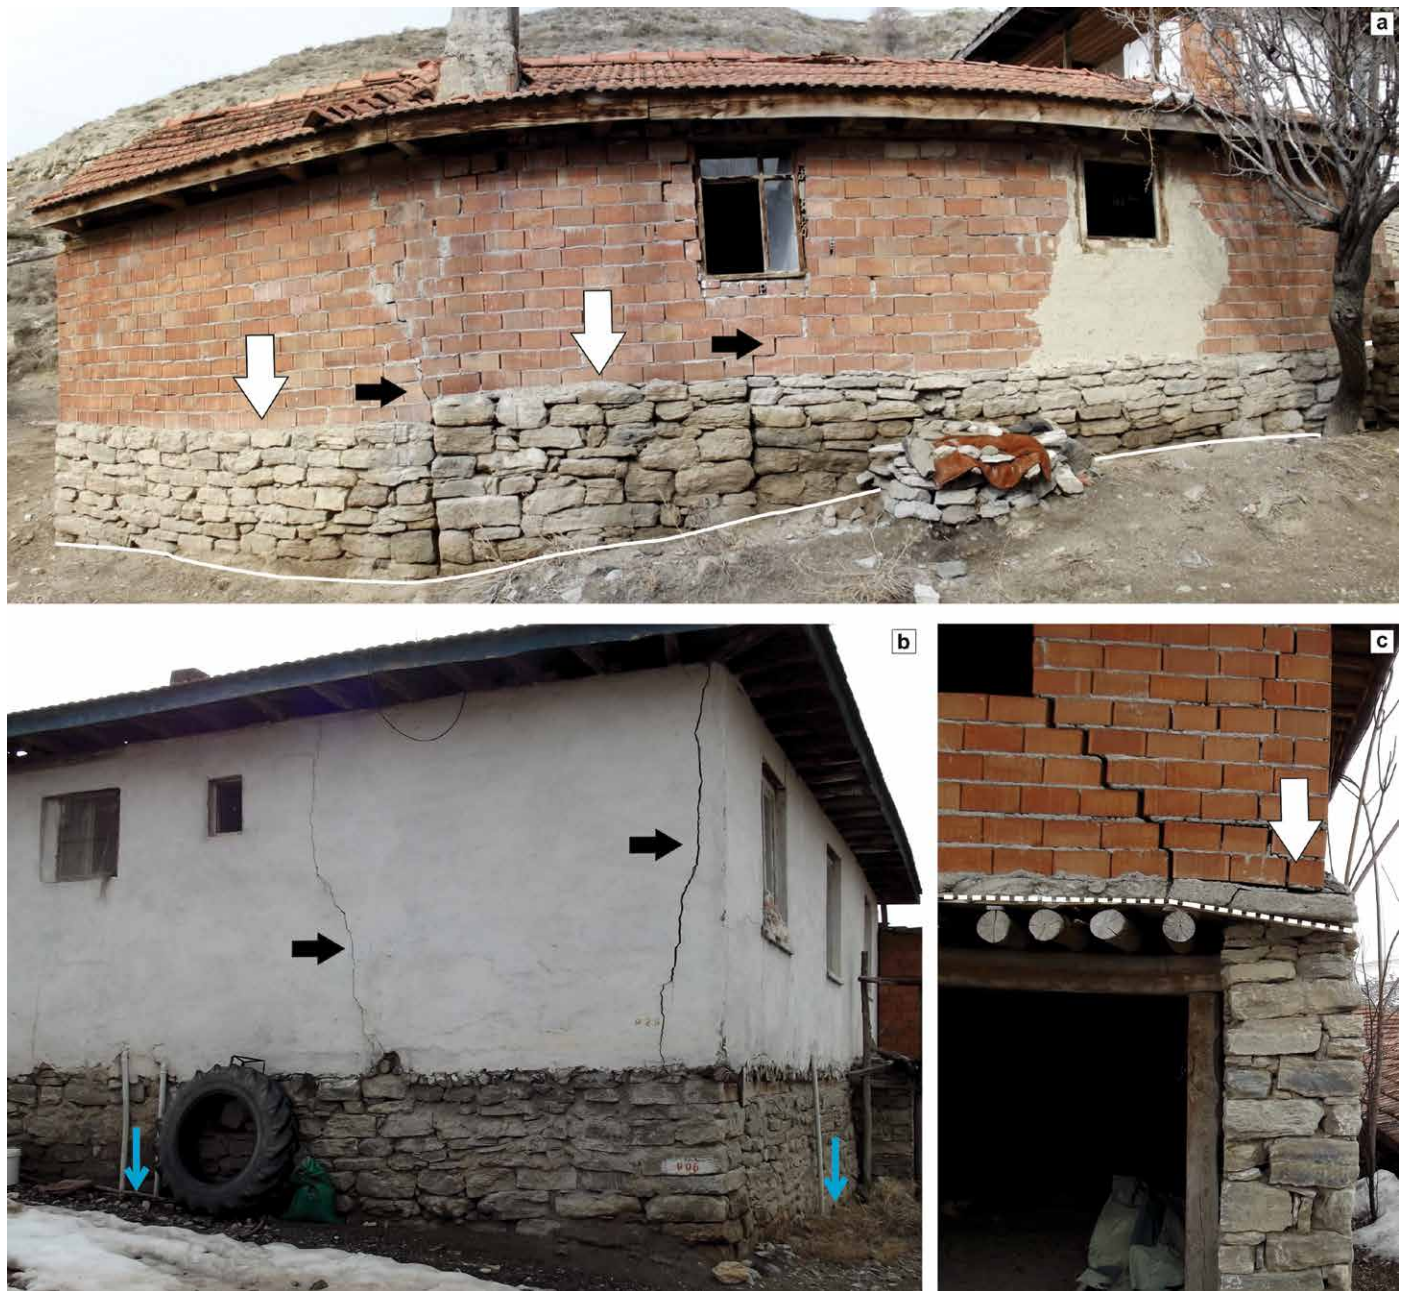
which show open fractures and tilted, cracked walls (Fig. 4). Moreover, some of the buildings are very old; therefore they are severely affected by even the slightest subsidence. Several have been demolished because the damage was beyond repair.

Figure 4. (a) Displacement of house wall showing bulging and cracking caused by subsidence, and broken windows due to distortion. (b) Cracks on wall and pipes draining wastewater directly into ground. (c) Open joint in wall of building. (Photographs taken on February 26, 2017).

sewage system was constructed in 2012. The pipes of these networks cracked and broke frequently and some homes still discharge water directly underground. This leakage has resulted in enhanced subsidence and progressive damage to buildings in the last decade. In consequence, the severity of the damage led to the decision to re-locate the village.

It is hoped that the results of this study will contribute to increasing the awareness among decision-makers who need to consider the karst system of the area they are responsible for in order to take preventative measures. To reduce or prevent hazards related to subsidence in a settlement which overlies gypsum, such as Inandık, extra water input to the subsurface should be minimized (Parise, 2015) and flexible pipes with a telescopic joint should be used to alleviate cracks and breakage.

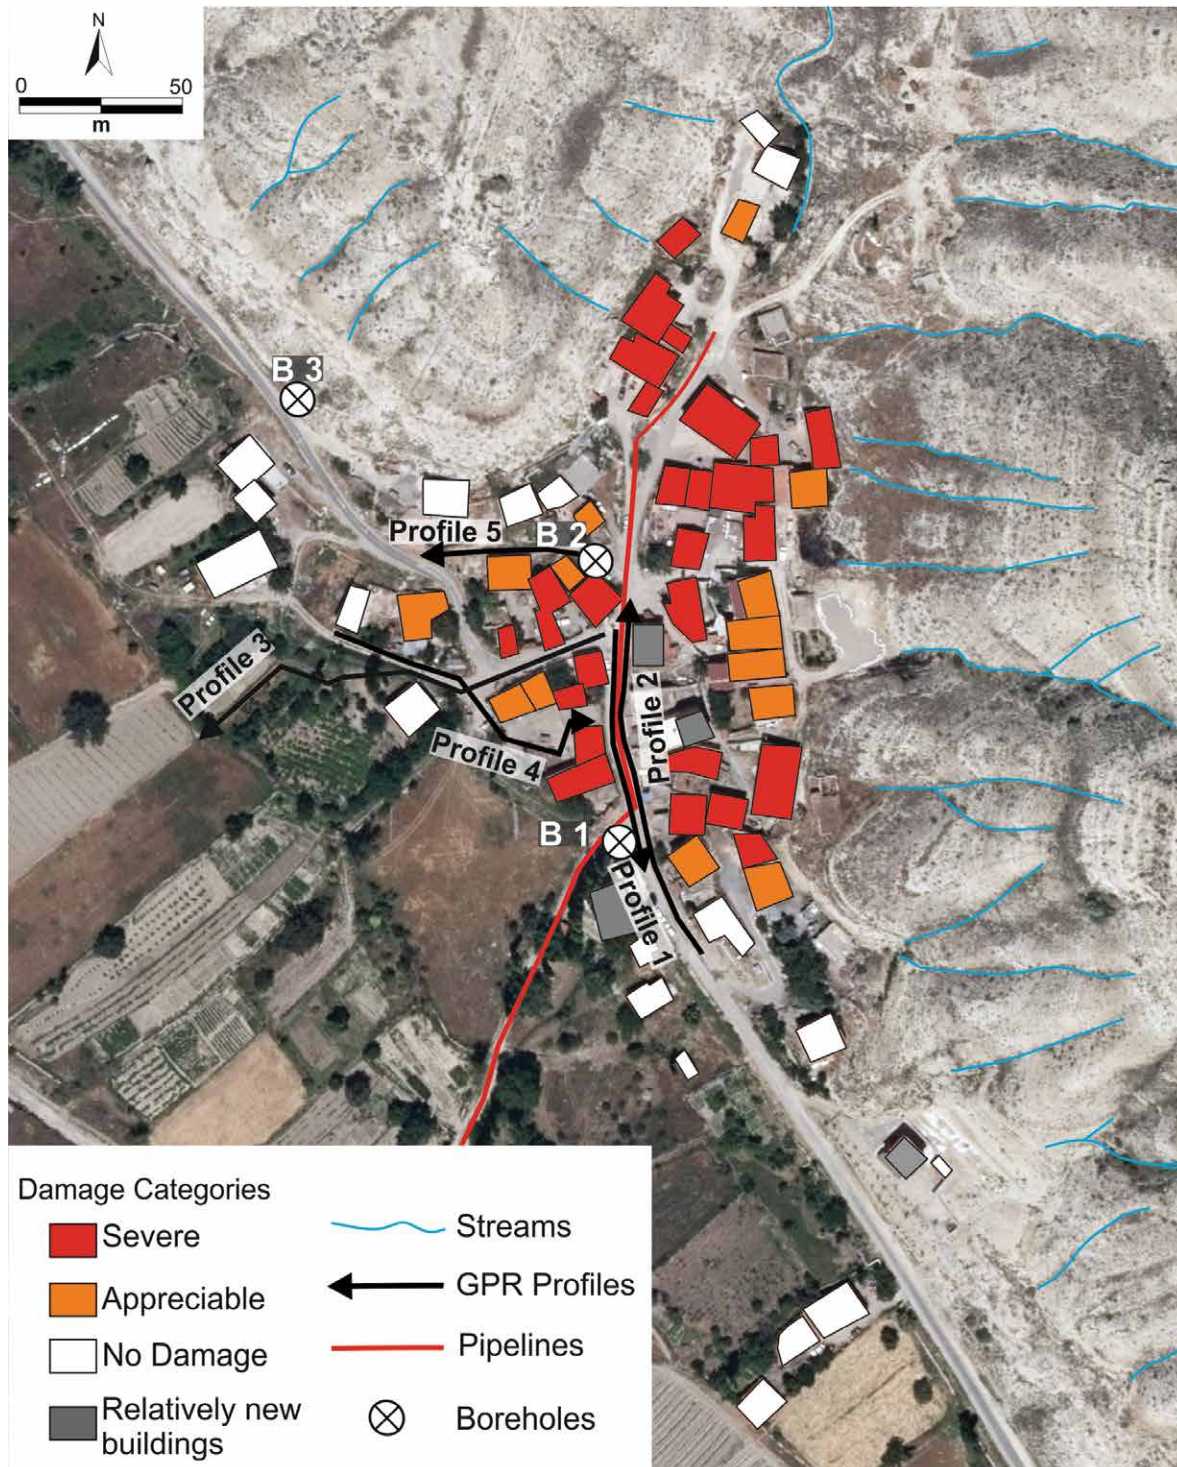
The map shows that most of the damage is concentrated at the bottom of small tributary valleys, whilst structures located in the main valley experienced no damage.

Figure 5. Map of damage distribution in March 2017 showing location of boreholes, GPR profiles (Özçelik et al. 2016) and pipeline.

According to the GPR profiles, cavities were detected only on profiles 1 (Fig. 6a) and 5 (Fig. 6b). However, the distribution map of subsidence damage (Fig. 5) shows that it affects a wider area than the GPR result indicates. It is known that the clay content of alluvium is an obstacle influencing the depth that GPR systems can reach (Schrott and Sass, 2008; Pueyo-Anchuela et al., 2009; Nouioua et al., 2013); therefore, the penetration of the GPR system was not satis-

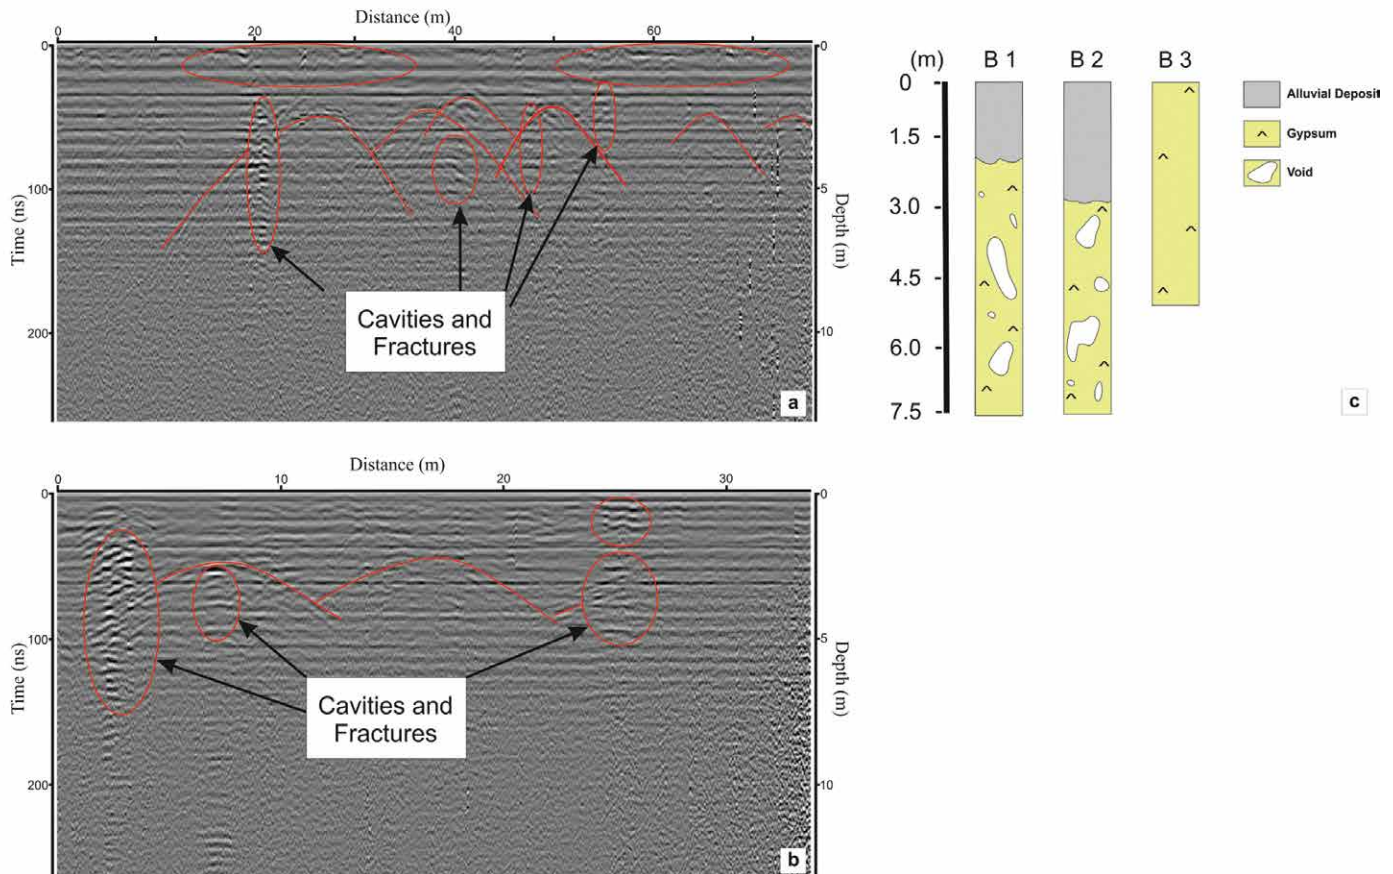
Five GPR profiles with a total length of 565 m (Fig. 5) were obtained from the settlement area (Özçelik et al., 2016). Profile 1 (Fig. 6a) mostly concentrates on the in-house and sewage water pipelines and shows shallow and relatively deep anomalies. Shallow anomalies between 20 and 32 m, and between 55 and 70 m are observed at a depth of 1 –

of the profile at a depth of 50-100 m. Profile 5 (Fig. 6b) focuses on the area northwest of the village. It shows anomalies located from the beginning of the profile at 10, 20, and 30 m and having a depth from 10 to 100 m. Shallow anomalies at 10 m and 25 m along the profile show a sagging structure. These anomalies seen on profiles 1 and 5 probably correspond to fractures, cavities, and sagging structures near the surface in the gypsum bedrock (Fig. 6a, b). Profile 1, located below the most damaged area, shows several anomalies more than profile 5, and both the anomalies and damaged buildings decrease towards the end of profile 5. These observations are compatible with the spatial distribution of the damage. Although the effect of subsidence was observed in structures near the other three profiles (Fig. 5), anomalies were not detected in these profiles.

Boreholes 1 and 2 were drilled in the valley bottom of Inandık village (Fig. 5). Both boreholes show dissolution cavities in the gypsum (Fig. 6c). According to this data, the thickness of the alluvium is 1.5-3 m. Borehole 3 was drilled on the bedrock northwest of the village. No void was detected in its log 3 (Özçelik et al., 2016).

Figure 6. GPR profiles of (a) profile 1, and (b) profile 5. (c) Log of boreholes drilled in Inandık village (modified from Özçelik et al. 2016).

The Inandık settlement is situated on 1.5-3 m alluvial deposits overlying a layer of gypsum, according to the boreholes (Fig. 6c). These thin alluvial deposits caused the village to be favorable for subsidence. On the other hand, the main valley has relatively-thick alluvial deposits SW of the village and buildings here show no damage (Fig. 5). The center of the village is subject to greater internal erosion because of its thin alluvial cover.

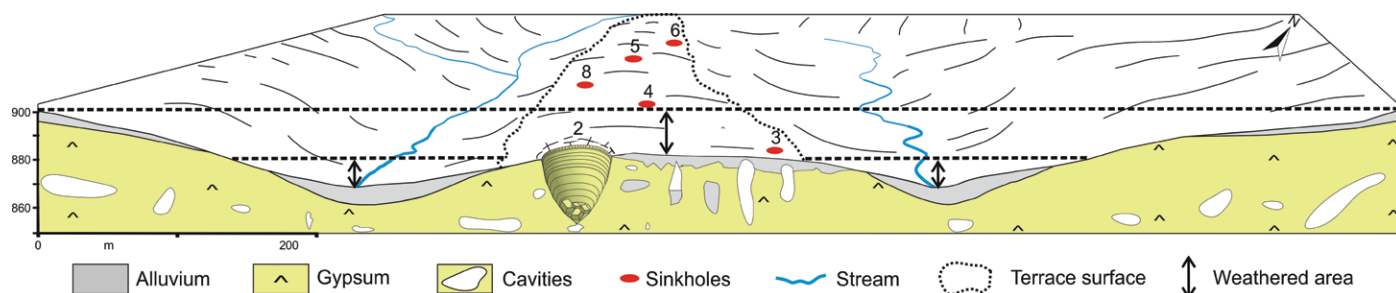
There was no sinkhole formation on the adjacent heights of the terrace (Fig. 7) because they have a relatively thick cavity roof. In the valley bottom, the alluvial cover is thicker and the hydraulic gradient is lower; therefore, only sinkholes 1 m wide or smaller were formed there.

Figure 7. 3D Geomorphological scheme (A-B) of Inandık stream showing flow level differences and sinkholes (See Figure 1c).

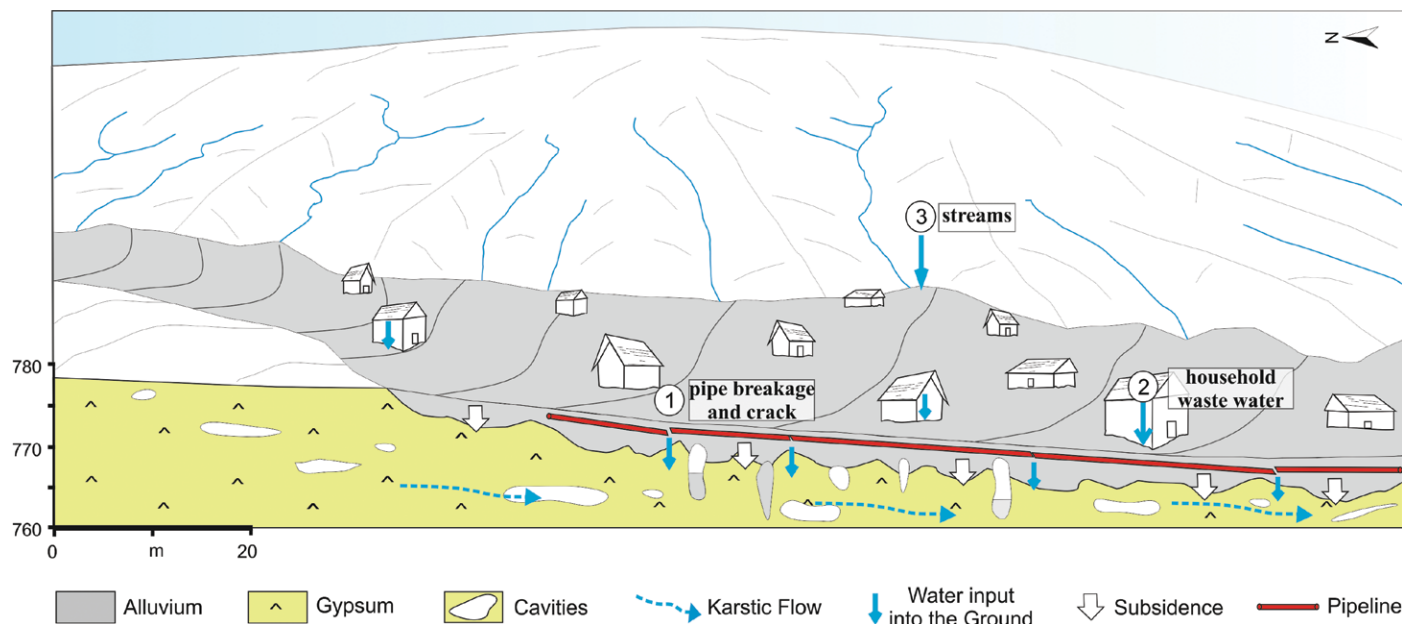
In-house service and sewer pipes are more likely to cause subsidence (Fleury, 2009; Parise, 2015) and pipeline breakage gives rise to damage in karst areas (Jassim et al., 1997; Gutiérrez and Cooper, 2002; Cooper et al., 2011; Cooper and Gutiérrez, 2013; Parise et al., 2015). In Inandık, ground subsidence must have caused the abnormally frequent breaking of pipes, which caused extra water input into the ground and triggered progressive subsidence of the land, creating a vicious circle. Moreover, some household waste water flows directly into the ground, which causes localized subsidence. All these processes give rise to dissolution and the formation of new cavities (Fig. 8).

Figure 8. Cross-section of pipeline (Fig. 5) and 3D geomorphological scheme of Inandık village depicting effect of subsidence.
