A REACTIVATED CAVE SYSTEM INDUCES RAPIDLY DEVELOPING COVER-COLLAPSE SINKHOLES IN TASMANIA, AUSTRALIA

Abstract

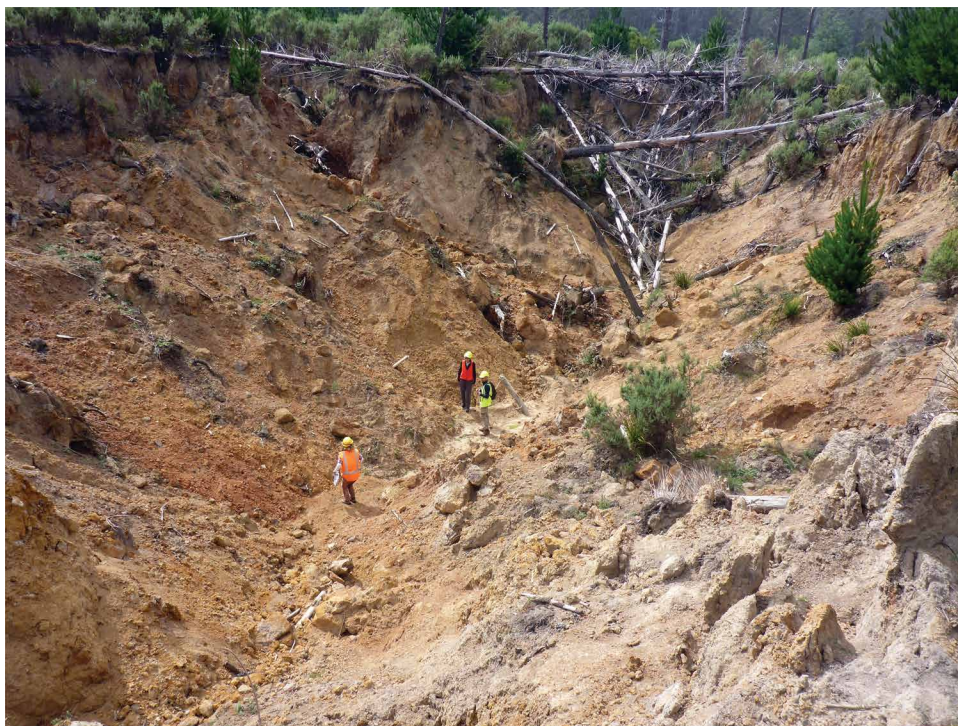
Figure 3. Sinkhole 1 in March 2019. This sinkhole formed in the winter of 2016 when several smaller sinkholes formed in 2013–2015 coalesced. It is the largest in the study area at over 60 m wide and 10 m deep with a footprint of 1450 m^2 . An estimated 6000 m^3 of soil derived from Quaternary deposits have been lost to the underlying karst at this site. The furthest figure is standing on an exposure of limestone bedrock with a small cave entrance into which runoff flows during heavy rainfall.

All the sinkholes noted are cover-collapse sinkholes (Fig. 3 and 4). Sinkholes in the study area tend to concentrate and enlarge along the major syncline fold axis (340°) implying that limestone dissolution (the ultimate control of sinkhole formation) is preferentially occurring along the syncline fold axis, as noted by Yan et al. (2008) and Goldscheider and Neukum (2010). Elsewhere sinkholes occur, often in a linear pattern, where limestone permeability is highest (e.g. Lolcama et al., 2002; Basso et al., 2013; Pepe and Parise, 2014; Kobal et al., 2015; Siska et al., 2016). Although the sinkholes in the study area were commonly circular in plan at the time of initial collapse, they elongate along the trend of karst drainage as a result of gradual soil loss by suffusion processes into the underlying karst aquifer, as described by Zhou and Beck (2008).

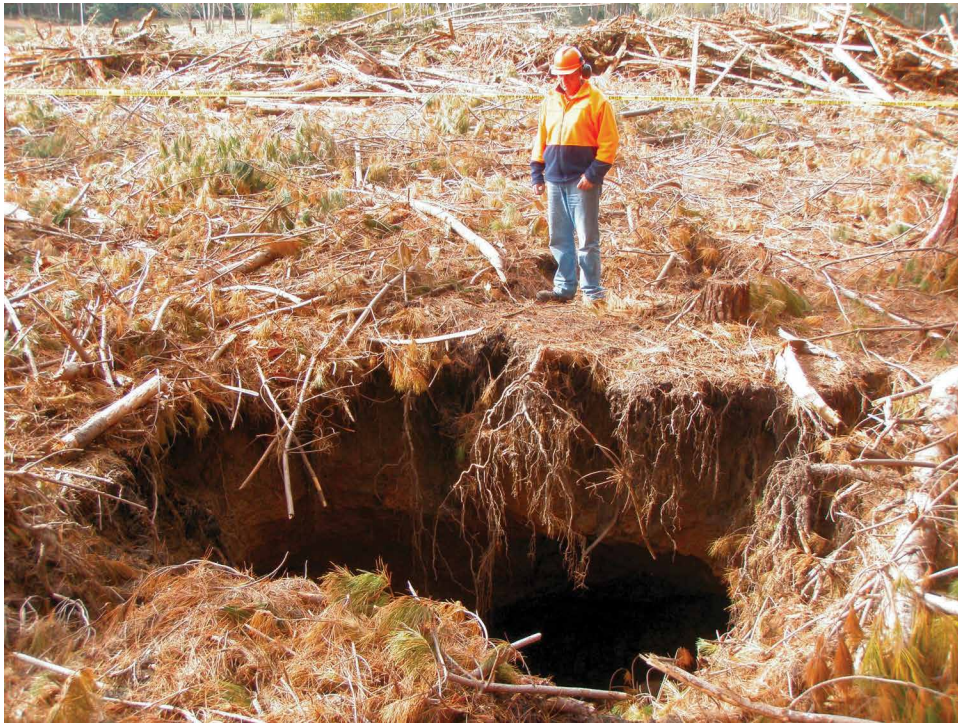
Figure 4. A contractor standing on the edge of a sinkhole (the precursor to sinkhole 3, Fig. 2), which formed between the close of the week’s work on Friday April 19, 2013 and the return of contractors on Monday April 22, 2013. The contractor is standing on vehicle tracks — a harvesting machine had crossed the area of the sinkhole on the previous Friday.

The karst-associated hazards in this area are: (1) unpredictable collapse during forest operations (Fig. 4); (2) threats to infrastructure such as the railway, the electricity transmission line, roads and the Dulverton Tip (Fig. 1); (3) changes to biodiversity of streams resulting from intermittent flows and drying of channels downstream of streamsinks; and (4) changed water chemistry. The study demonstrates that the risks associated with water-table lowering by quarrying in limestone are not limited to classical “cones of depression” immediately around quarries and mines. Effects are magnified if relict subsurface stream channels (cave systems) are intersected by mining, as predicted in this area by Jennings

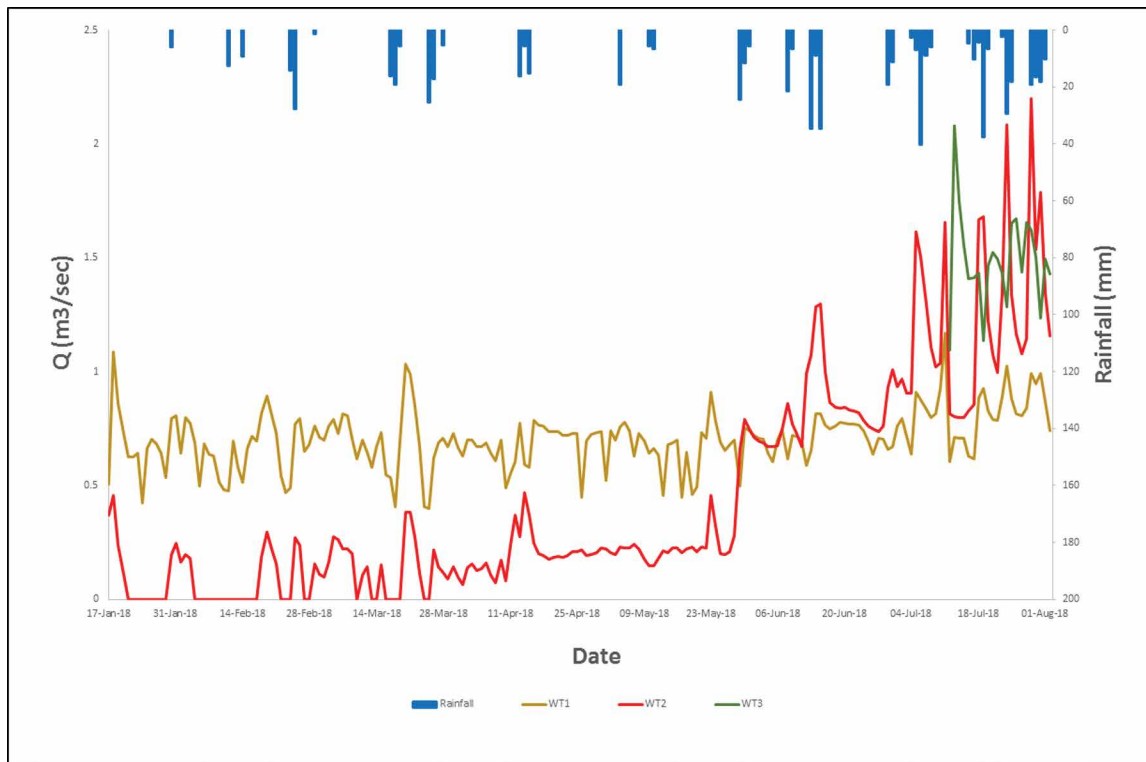
Figure 5. Flow records for Eastern Creek at ECS (brown line), Caroline Creek at CCS (red line) and Caroline Creek at DSS (green line), January 17, 2018 to July 31, 2018. Note the relatively uniform flow of Eastern Creek and the seasonal flow of Caroline Creek. Daily rainfall (mm) shown as blue bars.

The streams at CCS, ECS and CCC have different seasonal behaviour (Fig. 5). The flow in Caroline Creek at CCS is seasonally variable ($\mu = 0.46, \sigma = 0.45$ m/s): large flow peaks follow high rainfall and there is a gradual increase in total flow as winter progresses (Fig. 5).

quarry; from June to July maximum flow increased only by $0.15 \text{ m}^3 \text{ s}^{-1}$ relative to the January–April average. High flow of Eastern Creek during periods of higher rainfall (May–July) matches that of Caroline Creek (Fig. 5).

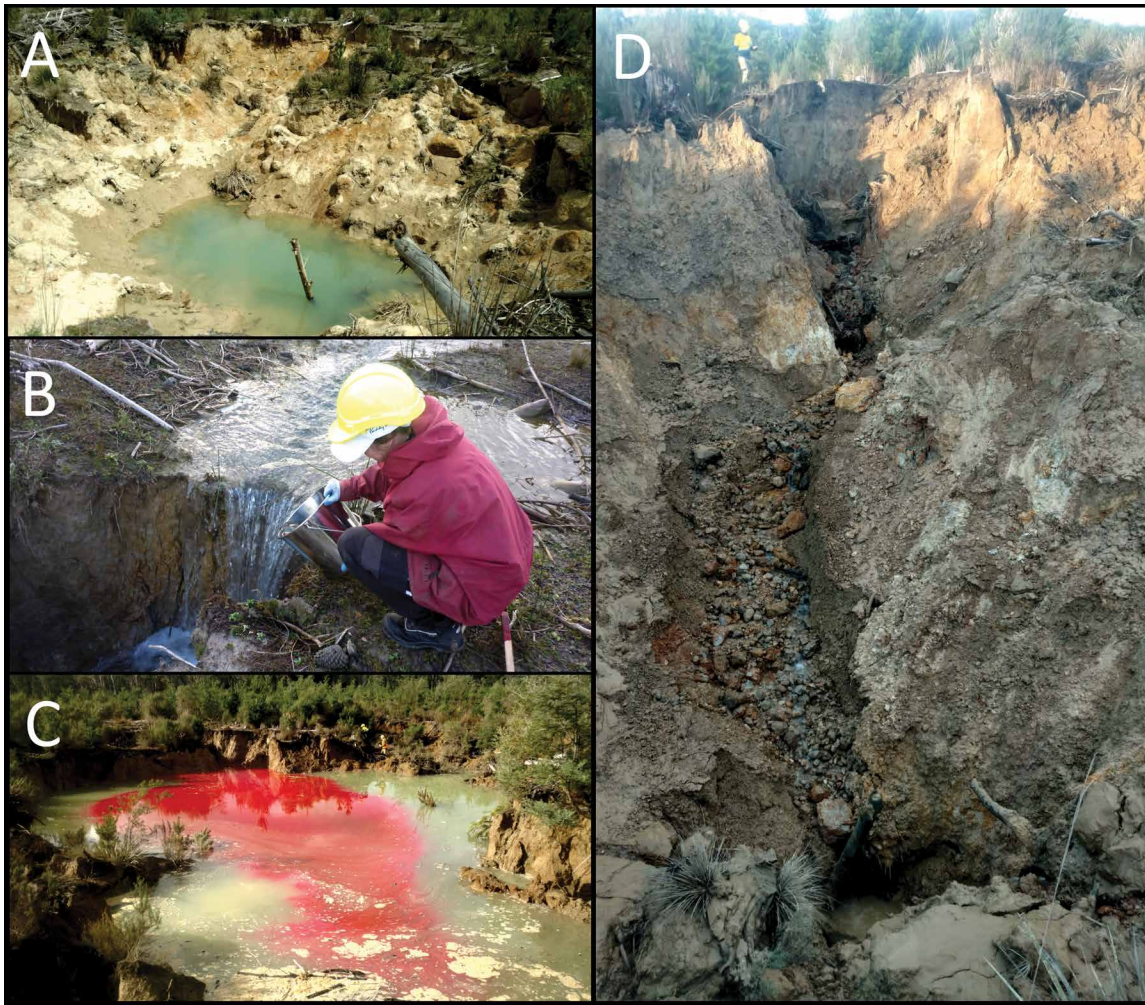
Figure 7. A. After heavy rain a lake (informally named Blue Lake) forms in Sinkhole 4 (photographed October 26, 2017); a small stream. B. (estimated flow 5–7 L/s) originating from a flooded Eastern Creek flows into it (photographed 26 July 2018). C. 870 g of Rhodamine WT dye was injected into this stream on July 26, 2018. D. By the afternoon of Saturday July 28, 2018 the lake had completely drained and the stream was seen cascading into an unstable vertical shaft at the base of the sinkhole which was over 7 m deep. The shadow line marks the approximate previous water level as shown in C.

Rhodamine WT dye was injected into the sinkhole informally named Blue Lake (BL) on July 26, 2018 (Fig. 6, Experiment 3 and Fig. 7) when flow into Blue Lake (from an overflowing Eastern Creek) was estimated to be $5\text{--}7 \text{ L s}^{-1}$. At the time of injection water was ponded in the sinkhole. Two days later water had completely drained into a visible cave at the base of Blue Lake. 0.026 ppb

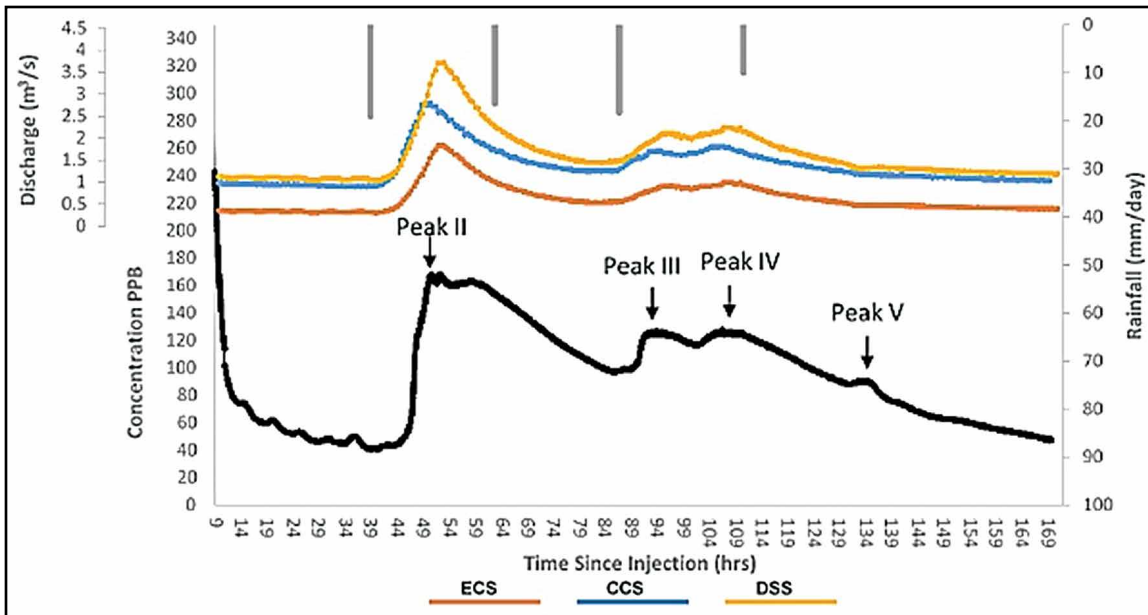
Figure 8. Fluorimeter dye trace record for Caroline Creek at DSN following fluorescein dye injection at CCS on July 27, 2018. The first peak occurred at 4.9 h and is not shown. The record illustrated covers the period 9–169 h following dye injection. Flow rates at ECS, CCS, and DSS are given on the y axis. Daily rainfall (mm/day) is shown by grey bars.

The fluorimeter results confirm the cycling of water between the streamsinks in Eastern Creek and Dulverton Pit. Five peaks in fluorescein concentration were observed at downstream Caroline Creek (DSN) following dye injection at the Caroline Creek streamsinks (CCS) during high flow (Fig. 9 shows the last four peaks). The initial and largest peak occurred 4.9 h after injection and is attributed to overland flow. (The dye had an approximate velocity of 0.21 m s^{-1} which is similar to the measured stream velocity of 0.31 m s^{-1} .) As fluorescein is rapidly decomposed by sunlight and approximately 50 % of fluorescein dye is decomposed within three hours of direct exposure (Feuerstein and Selleck, 1963), it is reasonable to conclude that any fluorescein still present in Caroline Creek surface water after the 4.9 h peak would have been destroyed by exposure to sunlight before the secondary peaks were recorded 50 h after injection. Therefore, the fluorescein dye must have been stored/transported underground following injection for it to be recorded in surface flow after 50 h.

There are two possible explanations for the four secondary peaks in fluorescein concentration. (1) The peaks have been caused by pulses through the karst system resulting from fresh rainfall in the Caroline Creek catchment, an explanation apparently supported by the peaks corresponding with increased flow following rainfall (Fig. 8). However, although such an effect is common in monitored karst springs (e.g. Goldscheider et al., 2008; Filippini et al., 2018), it is unlikely that small pulses of rainfall feeding an aquifer could result in such clear secondary peaks. (2) The peaks are due to recirculation of the dye through the ECS–Dulverton Pit–YR–ECS circuit as a result of quarry pumping. This second explanation is supported by the fact that the peaks coincide with increased flows in Eastern Creek attributed to pumping from Dulverton Pit (Fig. 8). Explanation 2 is therefore more likely to be correct.

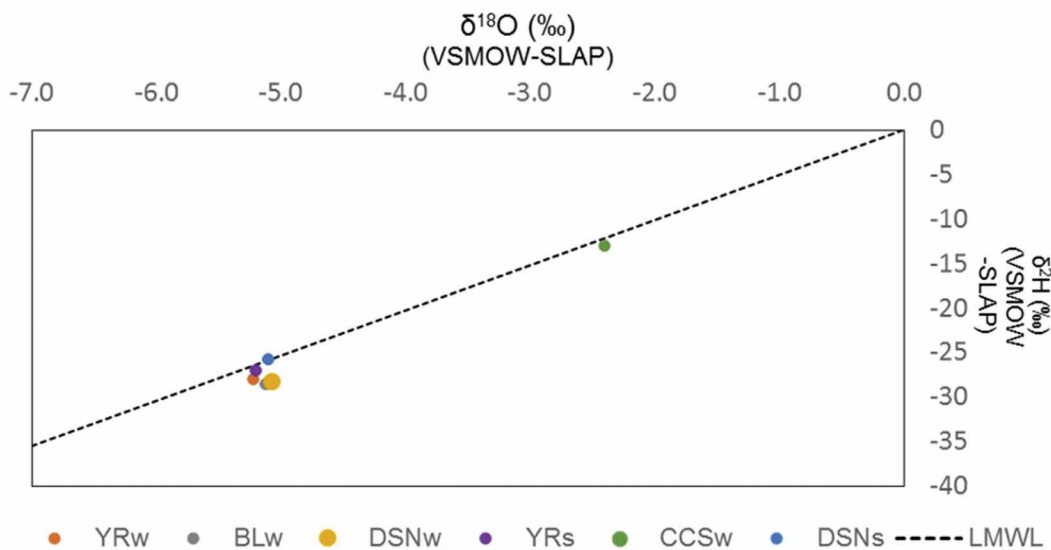
Figure 9. Water-stable isotopes of stream samples, plotted on the LMWL (Cape Grim, Tasmania; Liu et al. 2010).

Water stable isotope ratios for $\delta^{18}\text{O}$ and $\delta^2\text{H}$ for all samples fall on the Local Meteoric Waterline (LMWL) for Cape Grim, Tasmania (Fig. 9). At Cape Grim (162 km northwest of Railton) the variability of $\delta^{18}\text{O}$ and $\delta^2\text{H}$ isotope ratios in rainfall is reflected by enriched $\delta^{18}\text{O}$ isotopes in summer and depleted $\delta^{18}\text{O}$ isotopes in winter by a factor of approximately ± 5 (GNIP, 2018). Stable isotope ratios from samples taken in winter are depleted with respect to average rainfall isotope composition and range from -5.2‰ to -5.1‰ for $\delta^{18}\text{O}$ and -28‰ to -25‰ for $\delta^2\text{H}$, respectively. Water in samples from the Blue Lake sinkhole (BLw), Caroline Creek downstream of the recharge zone and confluence (DSNw) and Eastern Creek upstream of the recharge zone and confluence (YRw) are slightly more depleted in winter with values of -5.1‰ , -5.1‰ and -5.2‰ for $\delta^{18}\text{O}$ and -29‰ , -25‰ and -28‰ for $\delta^2\text{H}$, respectively. During both summer and winter Eastern Creek (YR) has depleted isotope signatures reflecting winter rainfall with values of -5.2‰ $\delta^{18}\text{O}$ and -28‰ $\delta^2\text{H}$ in winter and -5.0‰ $\delta^{18}\text{O}$ and -27‰ $\delta^2\text{H}$ in summer, respectively.

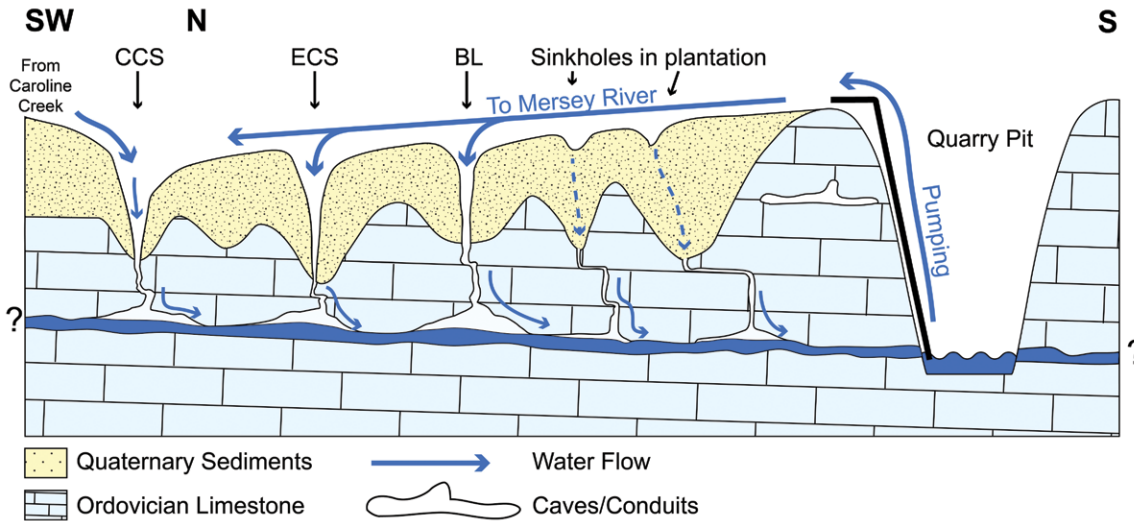
Figure 10. Diagrammatic representation of surface and subsurface flows induced by intersection of cave system at Dulverton Pit and pumping of water from Dulverton Pit to the headwaters of Eastern Creek. Not to scale. This representation is a simplification and the cave system involved may have multiple stream channels.

The hydrogeology results show that drainage in the Railton karst system is dominated by caves with high subsurface connectivity (Fig. 10). This type of karst system is best described as a 'dominant conduit model' (Vigna and Banzato, 2015; Filippini et al., 2018) in which (1) surface – groundwater connectivity is high and surface water rapidly infiltrates the system; (2) water is efficiently transported through the system by a network of connected subsurface conduits; and (3) flow is towards the zone of lowest hydraulic pressure. Preferential drainage routes are along weaknesses in the rock structure such as faults or folds.

We conclude that the primary cause of sinkhole collapse at Railton is intersection of groundwater, and specifically a cave system, by the limestone quarry (Dulverton Pit), as predicted by Jennings (1959, p. 7) who warned that “the limestone [at Railton] has been shown by drilling and quarrying to contain fairly large underground cave systems, and if these were encountered below the level of the water table, they would certainly drain embarrassingly large quantities of water into the cut”.
