RAW SEWAGE AND SOLID WASTE DUMPS IN LAVA TUBE CAVES OF HAWAII ISLAND

WILLIAM R. HALLIDAY

Hawaii Speleological Survey, 6530 Cornwall Court, Nashville, TN 37205 USA bnawrh@webtv.net

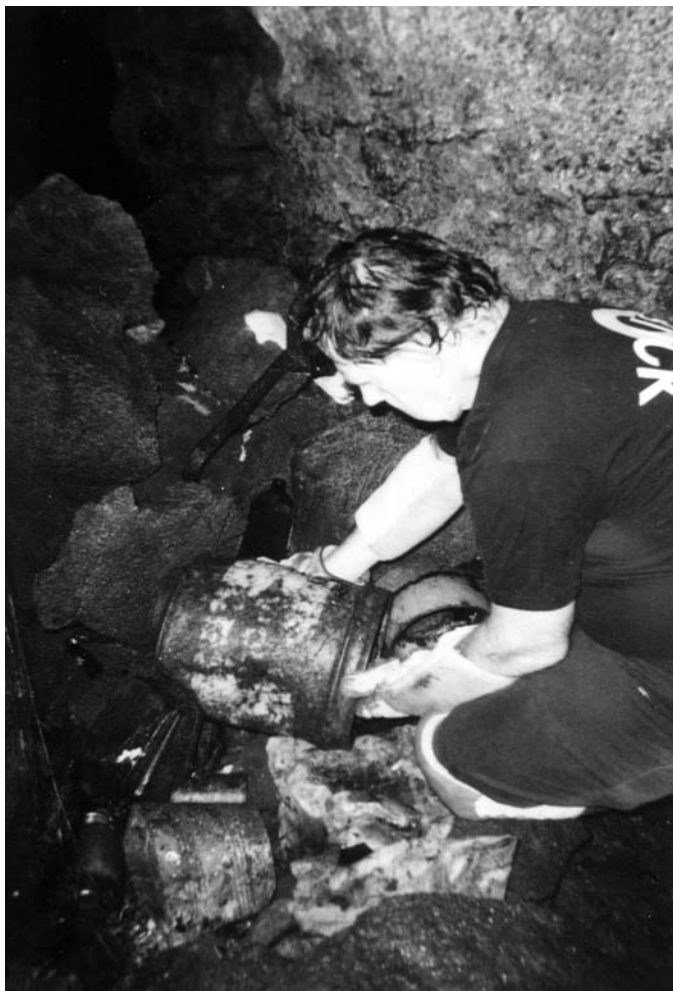
Figure 2. Incompletely drained containers of pesticides, herbicides, and other agricultural and automotive chemicals dumped in Kaumana Cave.

The cave's best-known garbage dump is located just downslope from Kilua Street, on State of Hawaii property. Partially emptied containers of hazardous and/or toxic waste are present (Fig. 2). Torrential rains of November 2000 compacted and partially distributed this dump down tube (Halliday 2001). Worn-out tires were washed more than 100 m to a point where they piled up against a rocky obstacle (Fig. 10). Smaller solid objects were washed up and over this obstacle and were jammed beneath rocks in the next chamber. Floatable waste

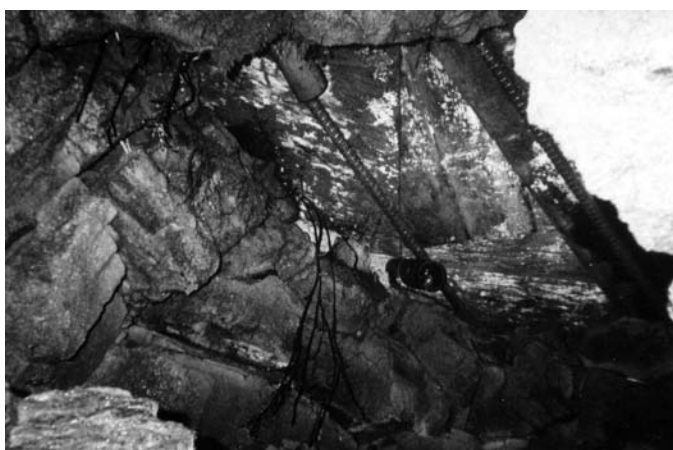
Figure 3. Looking diagonally upward to a pipe connected directly to a toilet in north Puna District, near Keaau. A pile of moist feces was present beneath the pipe.

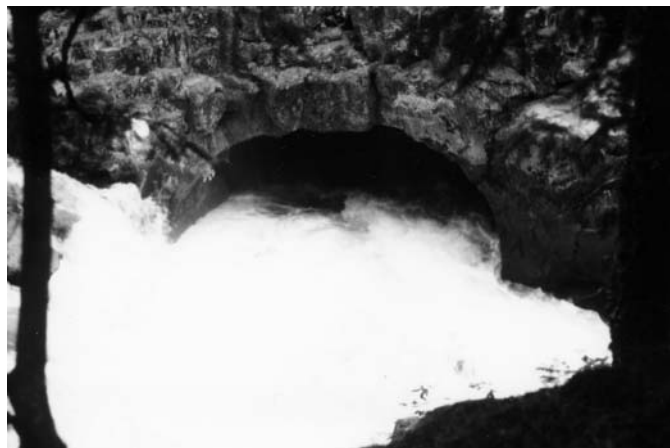
Figure 4. Spring runoff passing through a lava tube cave in the headwaters of the Rogue River, Oregon.

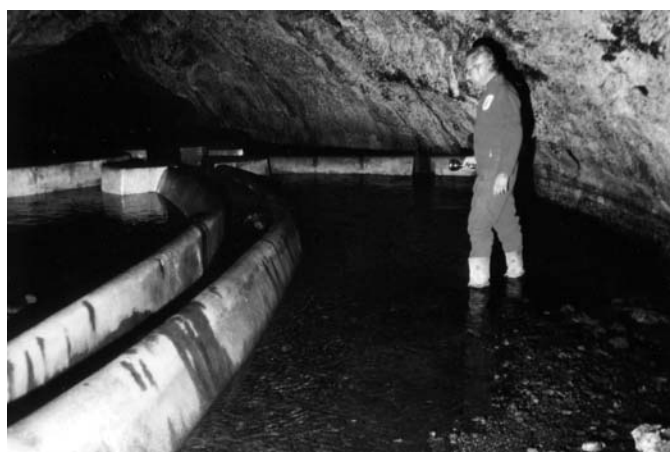
Figure 5. Artificial channeling of groundwater flow in a lava tube cave on the island of Terceira, Azores, Portugal, for domestic purposes.

Perhaps thinking of the now infamous "natural sewers" beneath Bowling Green, Kentucky, and other classical American karsts, Palmer (1946) wrote that "lava tubes (on the island of Oahu - W.R.H.) would be as good as artificial pipes, but they are far from common". More recently an enthusiastic journalist wrote that "when rain falls on the Big Island (Hawaii Island - WRH), it apparently collects in lava tubes and is whooshed down to the sea..." (Hastings 1989). Neither assertion was correct, but both contained important insights. In some parts of the world, lava tube caves function full-time as conduits for stream flow. In Oregon, a vigorous headwater of the Rogue River flows through a lava tube cave more than 100 m long (Fig. 4). On the volcanic island of Terceira (Azores, Portugal), spelean waterworks capture year-round stream flow to serve a town (Fig. 5). The stream in Utah's Duck Creek Lava Tube has been dammed to supply a local ranch. Other

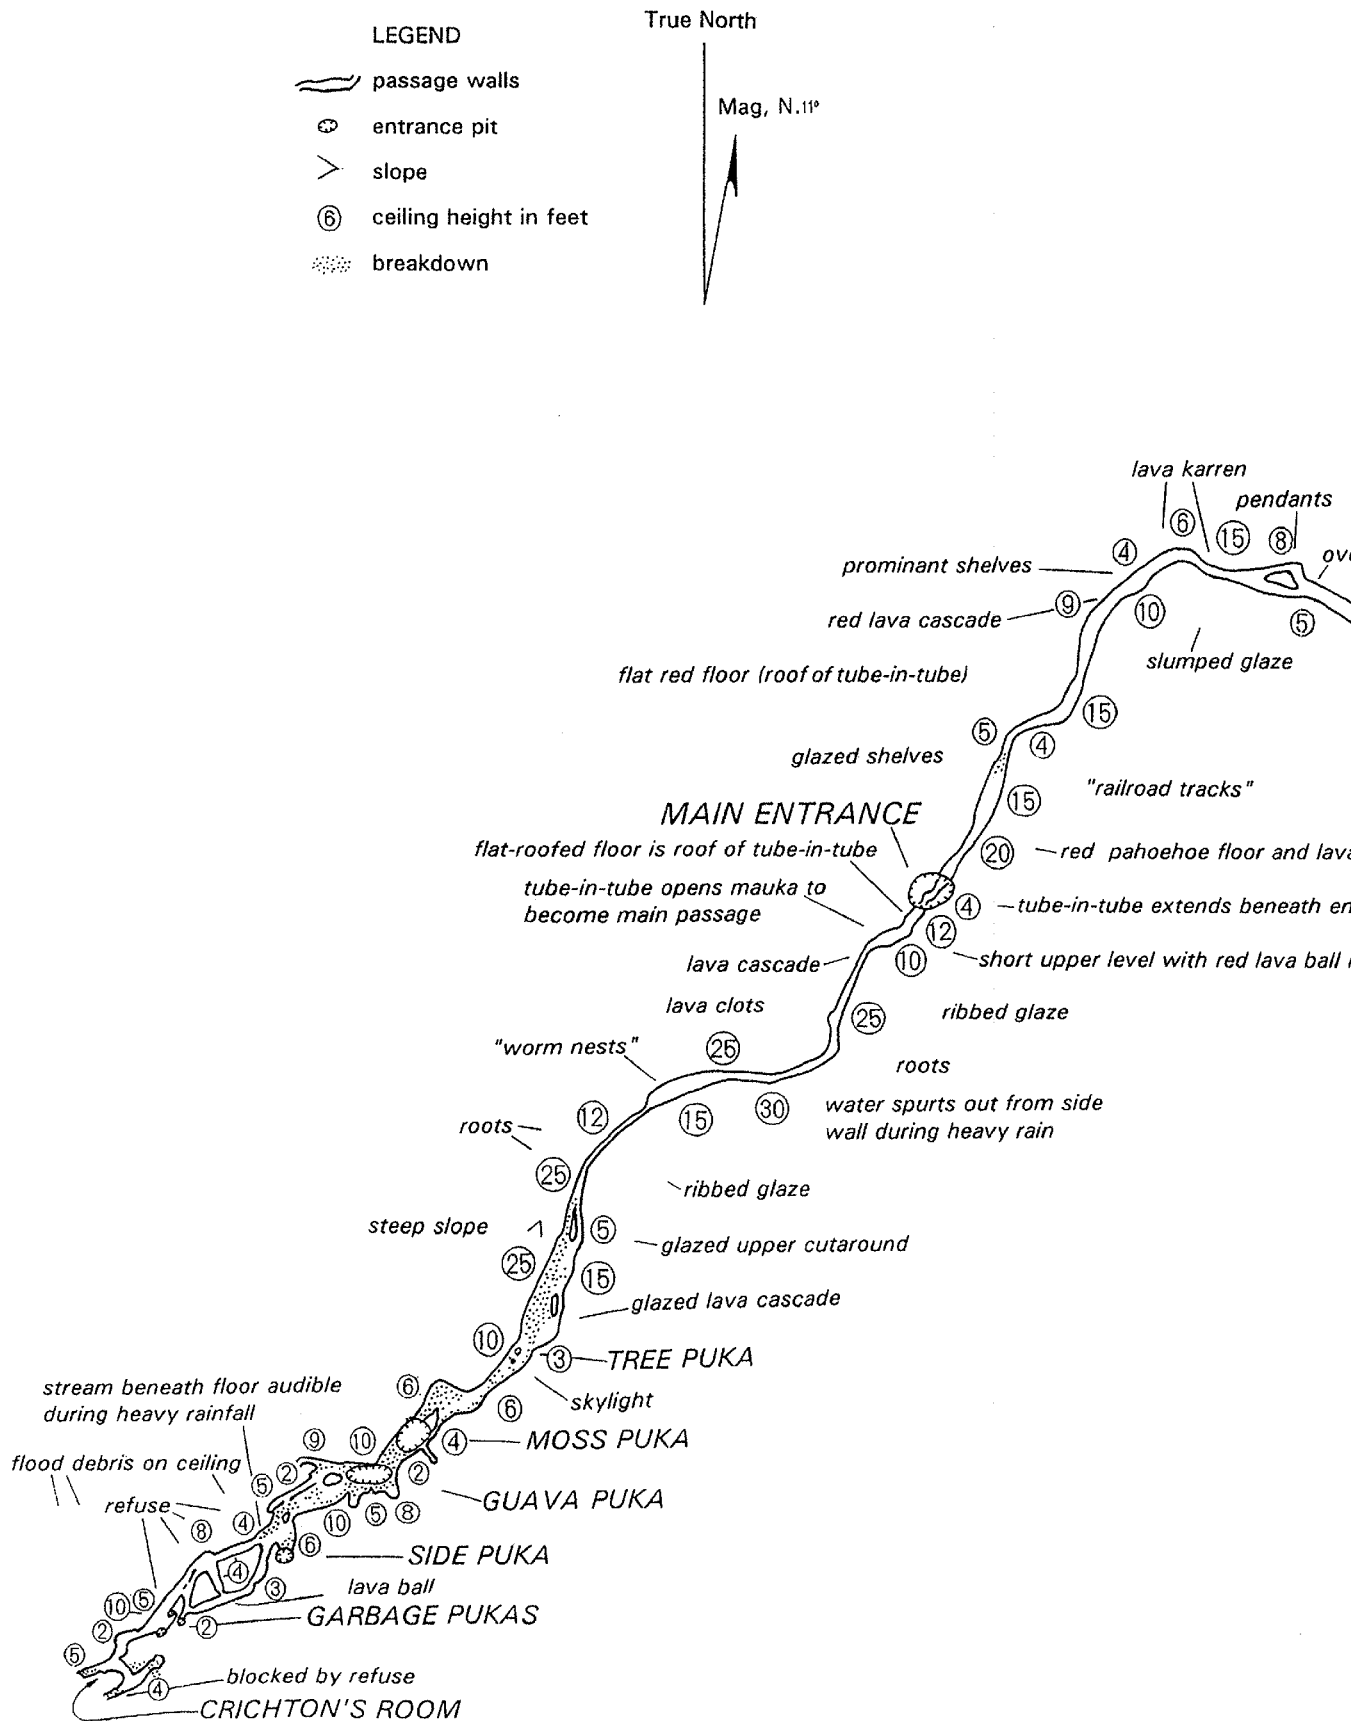
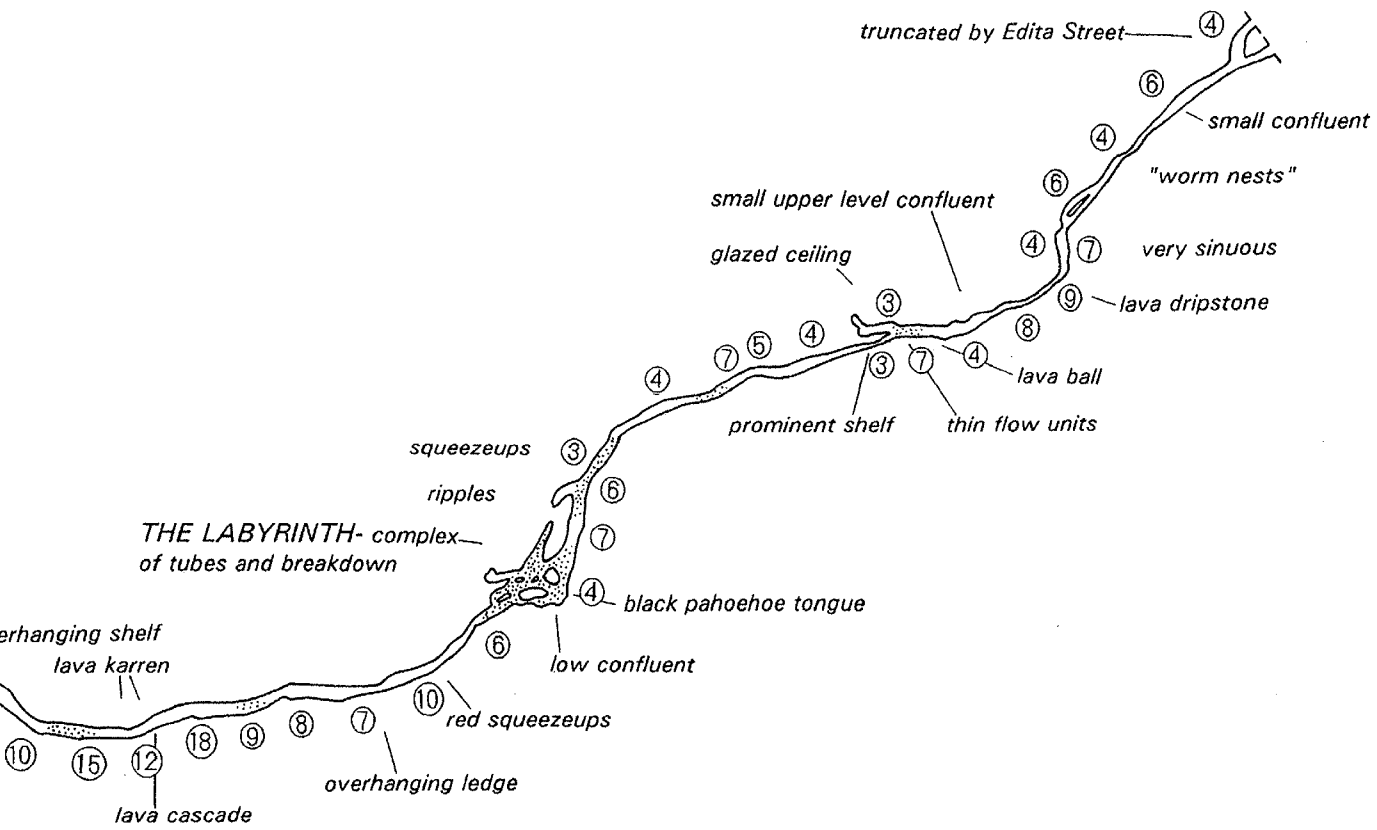
Figure 6.
Map, Kaumana Cave.

KAUMANA CAVE

SISTECO COMPASS AND CLOTH TAPE
 SURVEY BY THE HAWAII SPELEOLOGICAL
 SURVEY

7,210 feet shown

Located beneath a suburb of the city of Hilo, Kaumana Cave is an especially well known example (Fig. 6). Its main entrance section is the principal feature of Kaumana Caves County Park and is much visited. The lower 2.2 km of this cave (from Kilua Road to Edita Street) lacks streamflow unless rainfall exceeds ~20 cm within a period of 2-3 days: a common occurrence in all seasons. Stone (1992) has graphically described local flooding and fecal contamination in various parts of the cave that extend several kilometers upslope from Kilua Road. All known parts of the cave vary so markedly in shape and size that numerical estimates of streamflow discharge are challenging. No instrumental measurements are on record. It is visited so frequently, however, that numerous observations document location and general magnitude of streamflow under varying meteorological conditions.

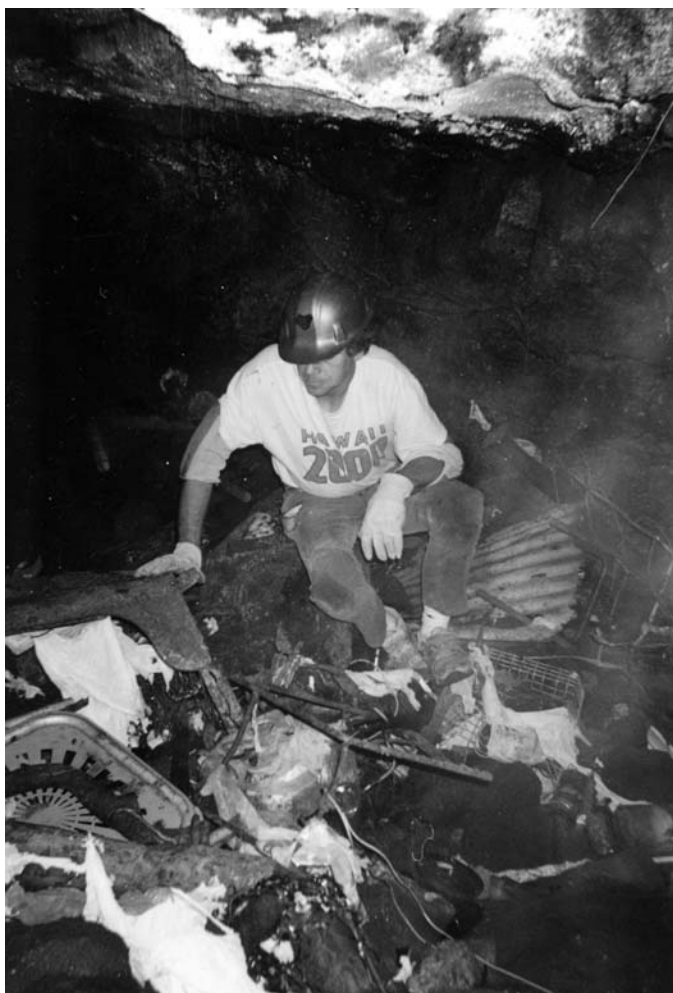
Figure 7. Part of the largest solid waste dump in Kaumana Cave, located in a suburb of Hilo, Hawaii.

This cave has been mapped several times, but only as far as Kilua Street where garbage becomes daunting (Fig. 7). In periods of normal rainfall, running water sometimes is audible beneath the floor of this section of the cave. Rainfalls of 20-30 cm produce waterfalls spouting from cracks high on the wall

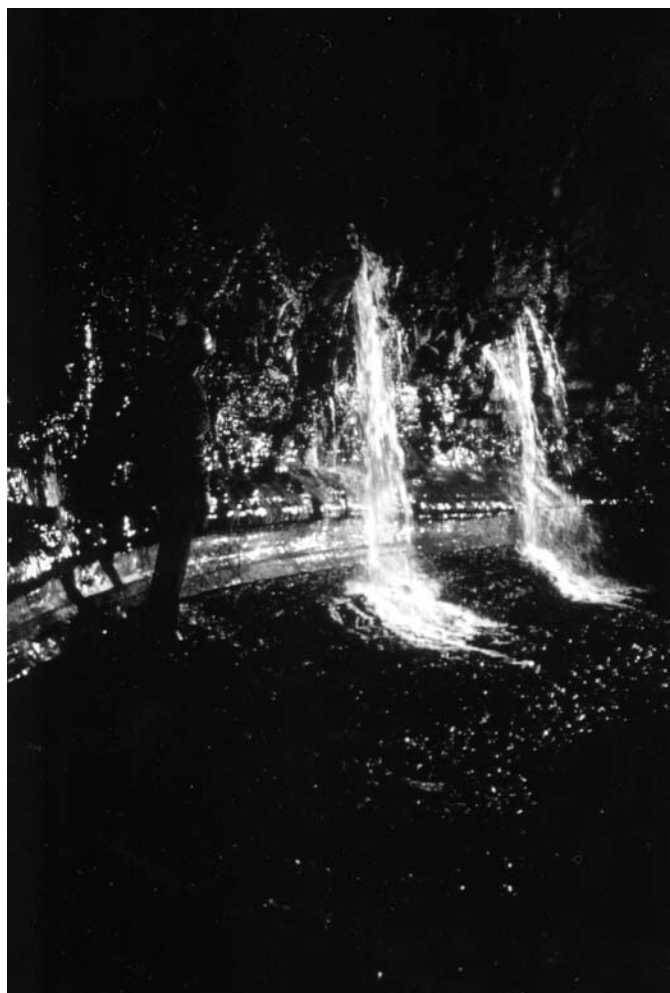
Figure 8. In addition to floodwaters which briefly fill much or all of Kaumana Cave, moderate rains cause episodic waterfalls two to three m high, spouting from the walls of the cave.

of one cave section (Fig. 8). They form a small stream that runs on or just beneath the floor for several hundred meters before finally sinking into cracks. Its flow is augmented by several small bubbling springs at or just above floor level and part of its flow also is lost into small floor-level cracks.

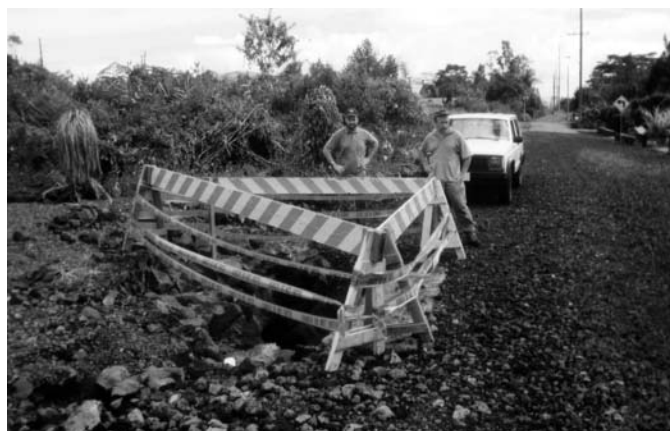
Figure 9. January 2001 photograph of overflow point of Kaumana Cave, in Kaumana community resulting from November 2000 flood. The location is the site of a former opening of the cave which was bridged to permit road construction.

During a record-breaking flood in November 2000, this cave overflowed through a ceiling orifice located in the gutter of Uhaloa Street upslope from the mapped section (Fig. 9), perhaps forcing a new opening at the edge of a metal plate embedded in the roadway at the site of a previous breakout 3-4 m above floor level.

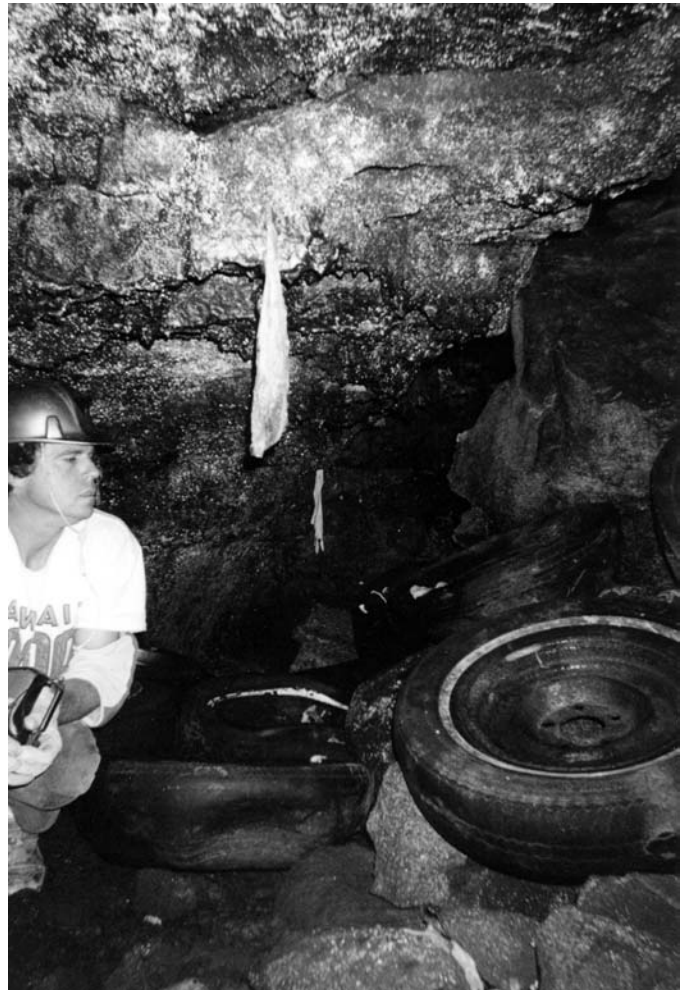
Figure 10. High velocity floodwaters washed these abandoned tires about 100 m down-cave from the main garbage dump in Kaumana Cave in November 2000. Here they were stopped by a pile of fallen rock. Lighter material from this dump was washed up and over this rockpile and was found at downslope points up to 3 m above the cave's floor.
